Application Note: Slow IR Response

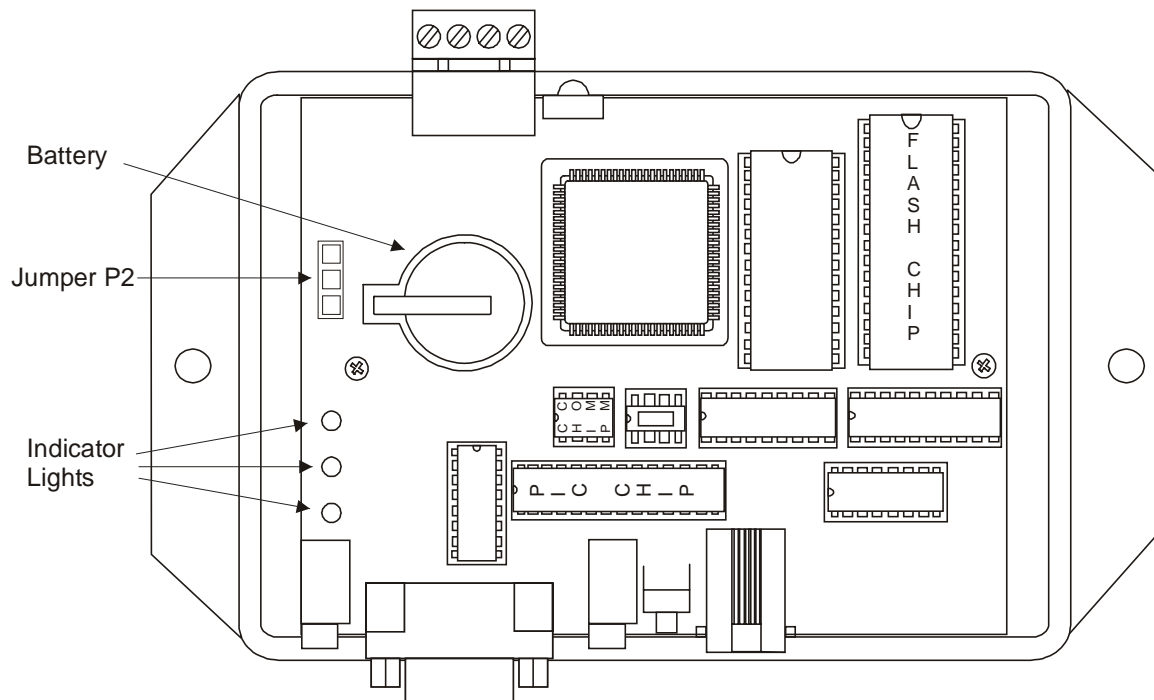
If you have a CPU/XA or an Ocelot with all red indicator lights (Active, COMMS and X10) and you experience slow infrared response after loading application version 2.85 into your unit, you will need to remove the jumper from P2.

Ocelots with Red and Green indicator lights will not experience this problem.

Remove the top from the CPUXA or Ocelot. P2 is located above the indicator lights next to the voltage regulator and the battery.
